Manhole Inspection Summary

Manhole # S35WW_005MH

Location Address: **202 31ST ST**

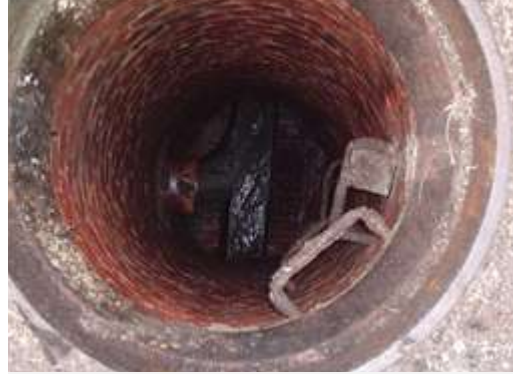
Top View

☒ **Debris** (not Condition related)

☒ **Corroded**

Corroded steps. Bench debris.

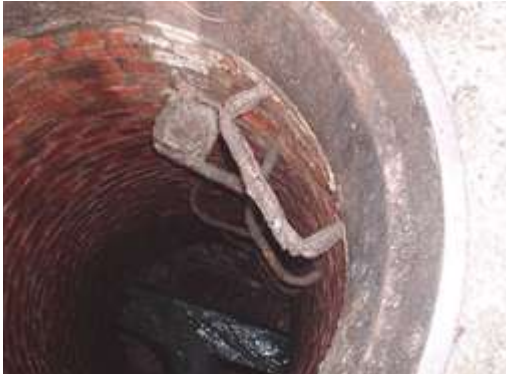
Defect

☒ **Leaks**

Condition: ☐ Sound ☐ Cracked ☐ Root Intrusion ☐ Loose Brick ☒ **Deteriorated**

Infiltration: ☐ None ☒ **Joint** ☐ Cracks ☐ Mortar ☐ Roots ☒ **Wall**

Frame leaks. Adjustment deterioration and infiltration.

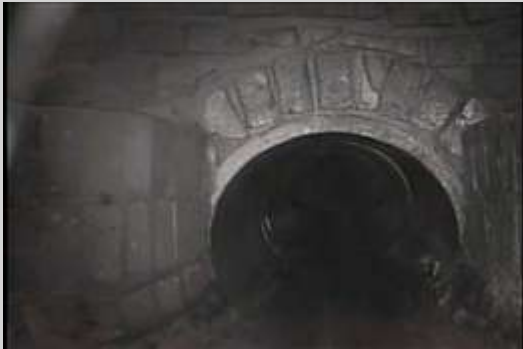
15 in. Circular Gravity Sewer Pipe Out @ 12 O'Clock

Invert Depth: **14.44** (ft.) Flow Characteristics: **Fast**

Infiltration: **None** Pipe Seal Cond: **Unknown**

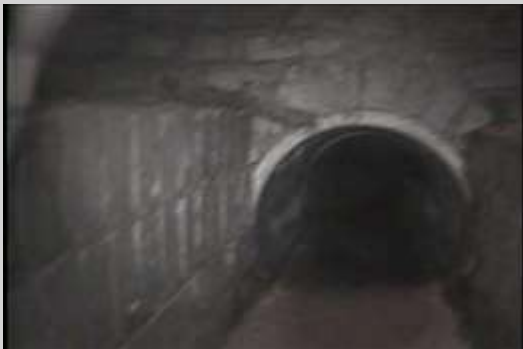
15 in. Circular Gravity Sewer Pipe In @ 6 O'Clock

Invert Depth: **14.30** (ft.) Flow Characteristics: **Fast**

Infiltration: **None** Pipe Seal Cond: **Unknown**

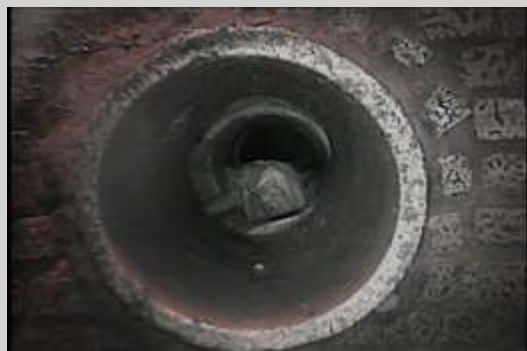
Pipe In @ 9 O'Clock

Infiltration: **Evidence**

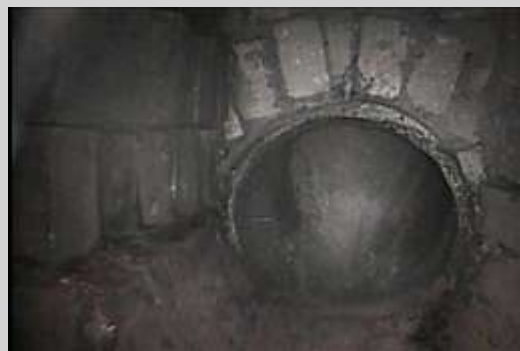
Drop In @ 9 O'Clock

Drop: **Outside** Rod and Bar

Drop Condition: **Open**
